# BV GENERIC FA 1 MD CHECKLIST

Mixing, moulding, spray painting and packing of fibre clay planter

Fibre clay planter - Product Category A

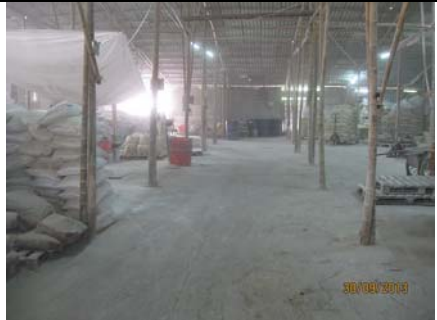
(4) Raw materials warehouse	(5) Accessories warehouse	(6) Semi-finished products warehouse

4.7.2	Measuring and monitoring equipment is routinely calibrated to recognised national standards.	Minor ( YELLOW )	Calibration program and schedule were established, most inspection and testing equipment were properly calibrated, but it was noted that one set electronic balance used in raw materials warehouse was not calibrated.

4.7.3	Records of equipment calibration and re-calibration are maintained.	Minor ( YELLOW )	Calibration records for most inspection and testing equipment were properly maintained, but no calibration record was maintained for the electronic balance used in raw materials warehouse due to no calibration.

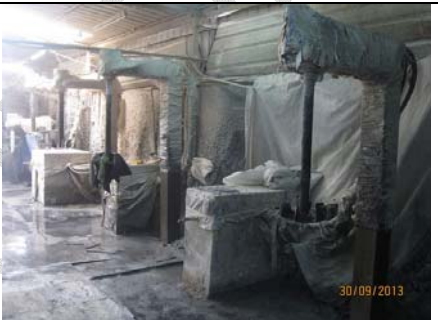
(7) Finished goods warehouse	(8) Materials mixing area (No work instruction)	(9) Moulding workshop

4.3.1	Working aids (data sheets, working instructions, and templates, etc) shall be installed on working areas and utilised by the operators.	Minor (YELLOW)	Work instructions were properly established for all processes, and provided in most working areas to give employees as guideline, but it was noted that no work instruction was provided in

materials mixing area.
4.3.4	A duplicate of an approved production sample with comments shall be provided and in use for all necessary operations as reference for operators.	Minor ( YELLOW )	First article inspection was conducted, but no approved sample was provided on site during this audit.

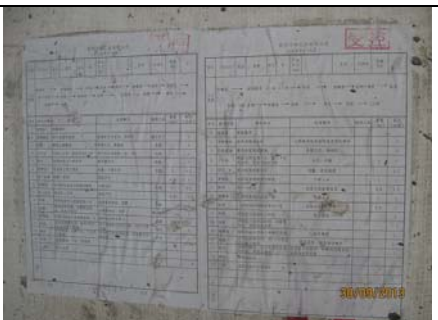
(10) Spray painting workshop	(11) Packing area	(12) Work instruction on site

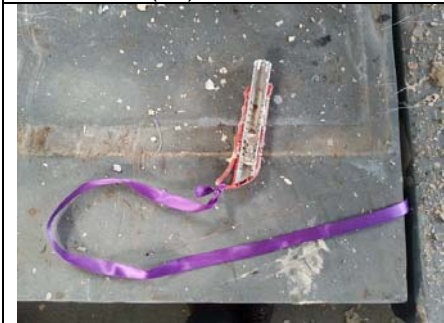
(16) Sharp tool fastened to the workbench

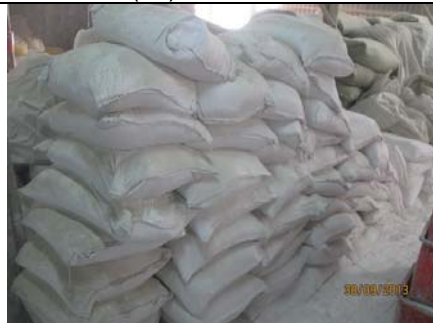
Clause No.	Clause Requirement	Levels of Non-Conformance	Audit Findings
<b>1</b>	<b>QUALITY MANAGEMENT STANDARD (QMS)</b>		
1.3.1	Raw materials (including packaging), work in progress and finished products shall be identified to ensure traceability.	Minor (YELLOW)	Identification procedure was established, and most raw materials, semi-finished products and finished products were found properly identified with sufficient information to ensure traceability, but it was noted that some MGO materials in raw materials warehouse, some semi-finished products in moulding workshop were not identified to ensure traceability.

(17) MGO materials not identified in raw materials warehouse

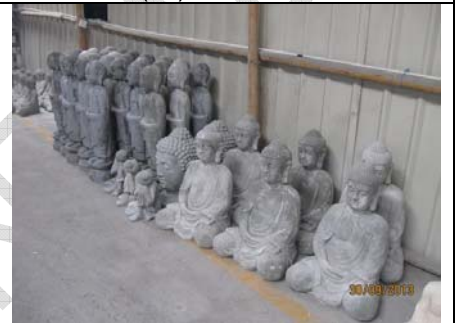
(18) Semi-finished products not identified in moulding workshop

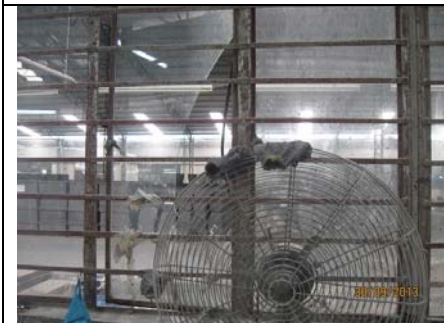
2.1.1	Building exterior and interior shall be maintained in good conditions to prevent product contamination.	Minor (YELLOW)	During this audit, it was noted that some glass windows were broken in moulding workshop.

2.8.2	Where there is a risk of contamination, glass windows shall be protected against breakage or product adequately protected.	Minor (YELLOW)	All glass windows were not properly protected in the factory.

(19) Broken glass window in moulding workshop

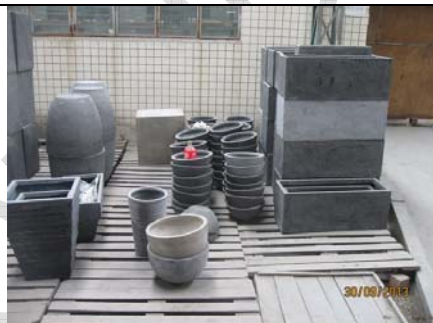
3.7.1	The company shall establish procedures for the identification, segregation, investigation and disposition of non-conforming raw materials (including packaging), work-in-progress and finished products.	Minor (YELLOW)	Non-conforming products handling procedure was established, and most non-conforming materials and products were properly identified and segregated, but it was noted that some non-conforming semi-finished products in semi-finished products warehouse were not properly identified and segregated.
<b>4</b>	<b>PROCESS CONTROL</b>

(20) Non-conforming semi-finished products not properly identified and segregated in semi-finished products warehouse

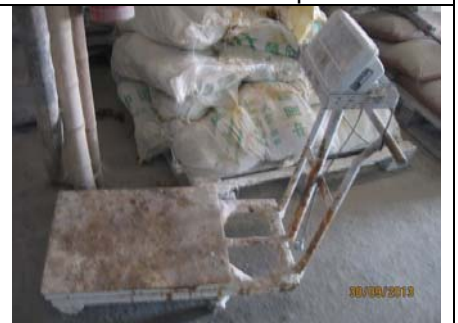
(21) Electronic balance not calibrated in raw materials warehouse
